Hyperspectral Moisture Detection Coupled with LIDAR Mapping to Characterize R-Reactor Seepage Basin Concrete Cap

PI: Juan J. Hernandez, FIU - Support: Troy Lorier, Christine Langton, Jeffrey Steedley, Dalton Hare
Applied Research Center, Florida International University

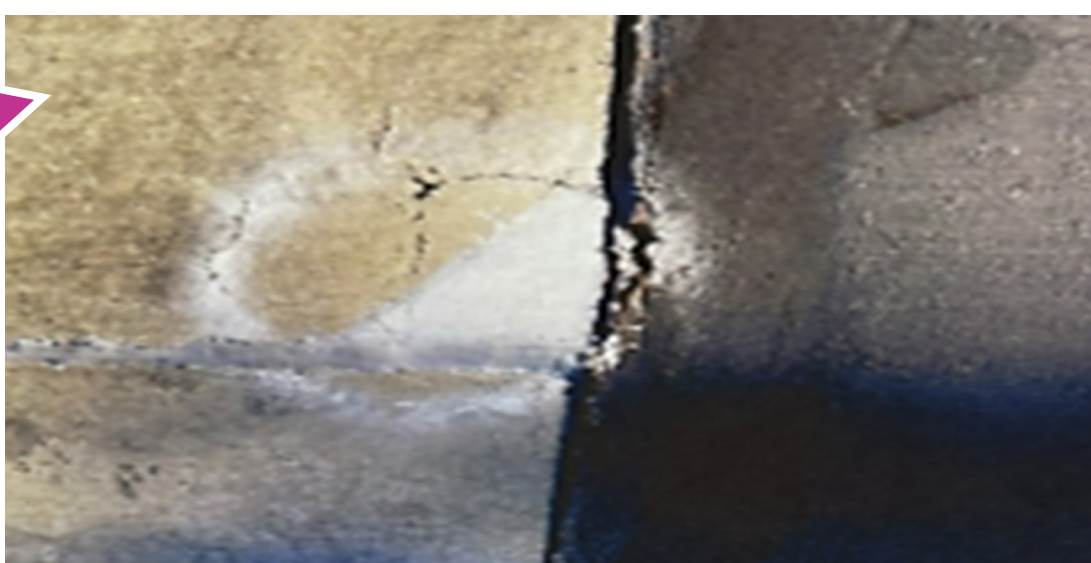
Figure 4. Concrete cracks

Concrete degradation begins microscopically. Cracks introduce spectral anomalies in the 750–950 nm range. These changes are detectable with hyperspectral imaging even before the crack becomes visible.

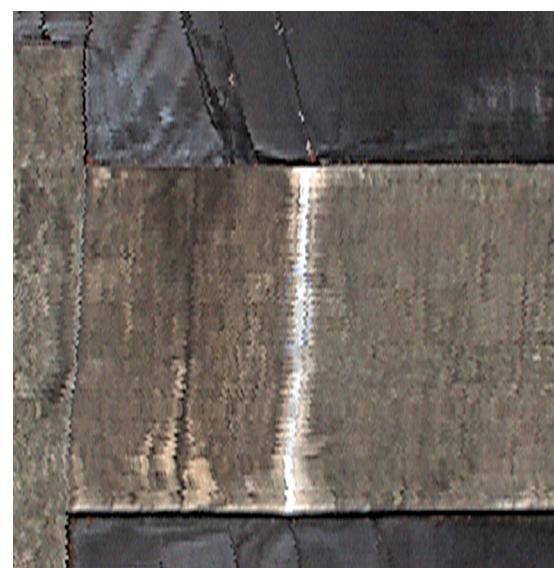
Figure 6. Aerial scan of zone 1

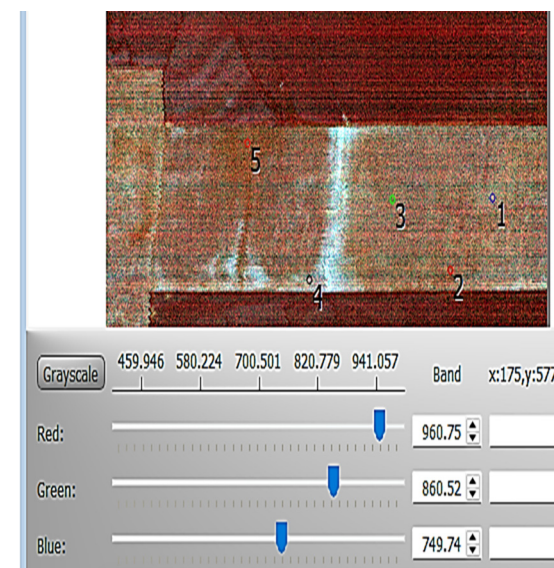
Figure 7. False RGB for Concrete Scanning

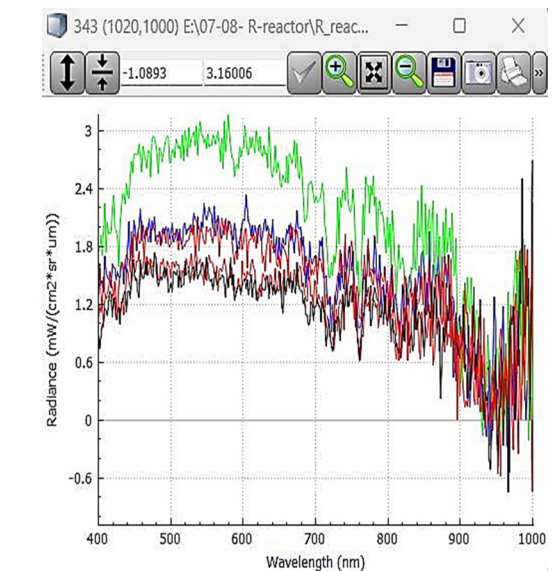
Figure 12. Asphalt Radiance vs Wavelength

- Radiance remained consistent across all probe points, confirming stable lighting and sensor performance.
- Reflectance values varied between damaged (Concrete points 1 & 2) and undamaged areas (concrete point 3,4,5), indicating material differences.
- Changes were most noticeable in the near-infrared range (750–950 nm), where degradation alters how concrete reflects light.
- The Increase and decrease in reflectance between different probe points provides clear spectral evidence of surface deterioration changes.
