INNOVATING **NUCLEAR** TECHNOLOGY  
ANALYSIS AND MEASUREMENT SERVICES CORPORATION

# EMC Troubleshooting in Nuclear Instrumentation Systems

2026 Mirion Connect Conference

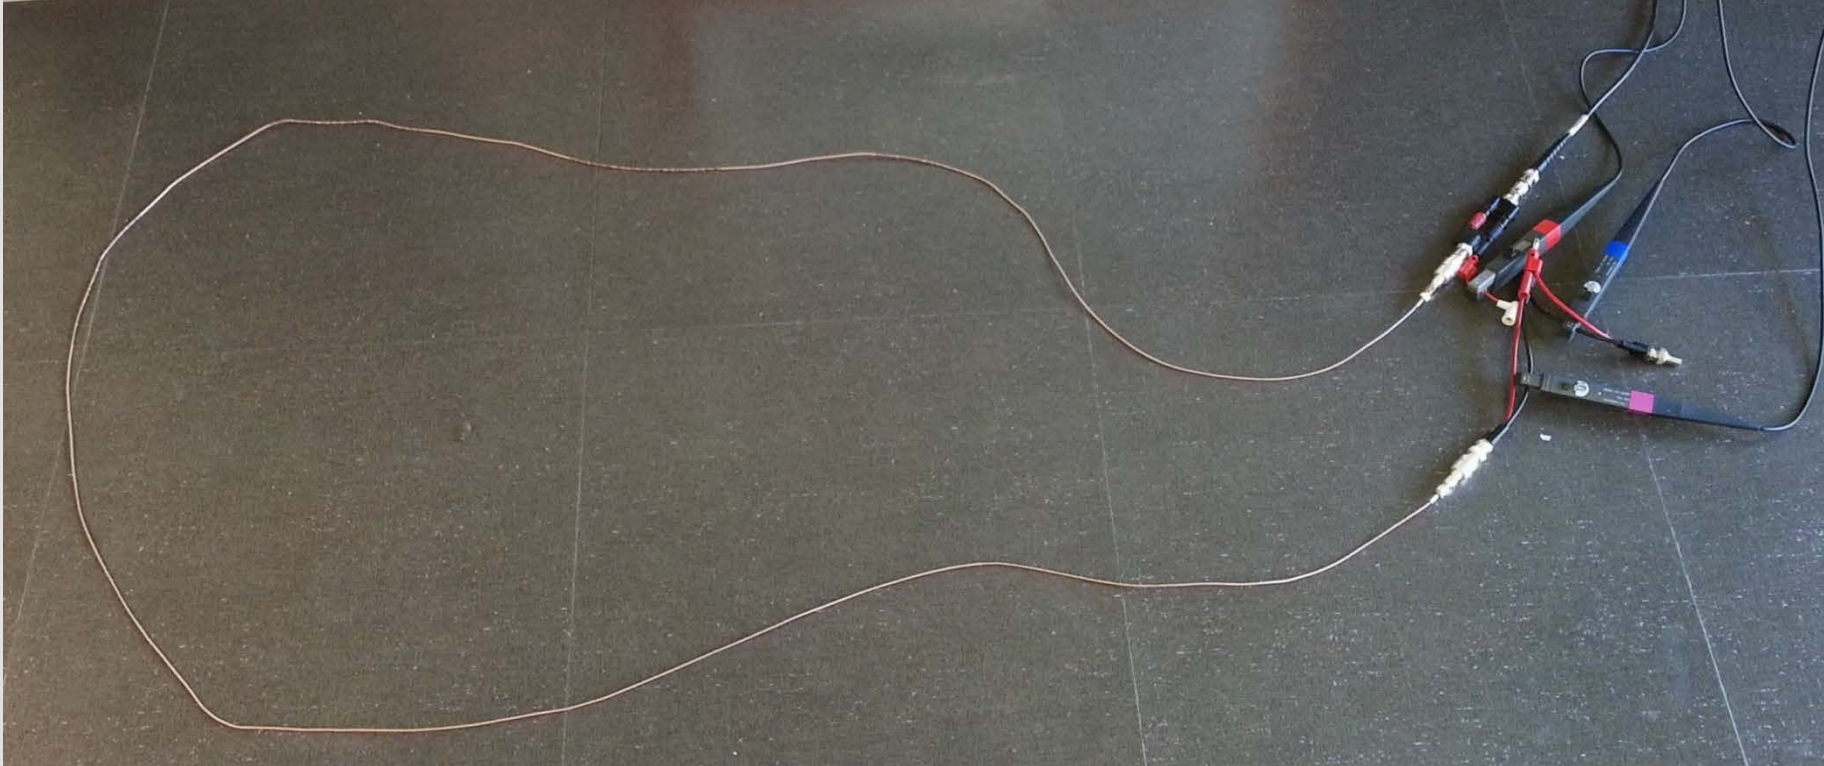
# Where Does Current Flow?

**Cable Length – 10.5 feet; 153 m $\Omega$**   
**Short section – 3 inches; 3 m $\Omega$**

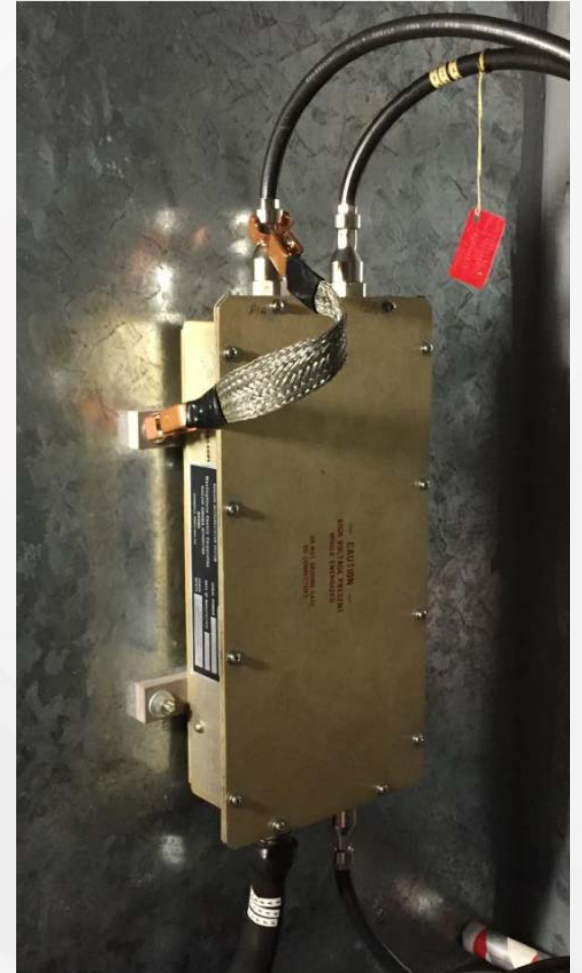
- Removal of ferrite beads allow the noise to spread out on the cables exiting the preamplifier
- Noise was reduced to a level below the N32 discriminator setting
- Eliminated false counts
