# *Troubleshooting Radiation Monitoring Systems Methods and Best Practices*

**Mehran Mohammadian, P.E.**

*Mirion Connect | Annual Users' Conference 2026*

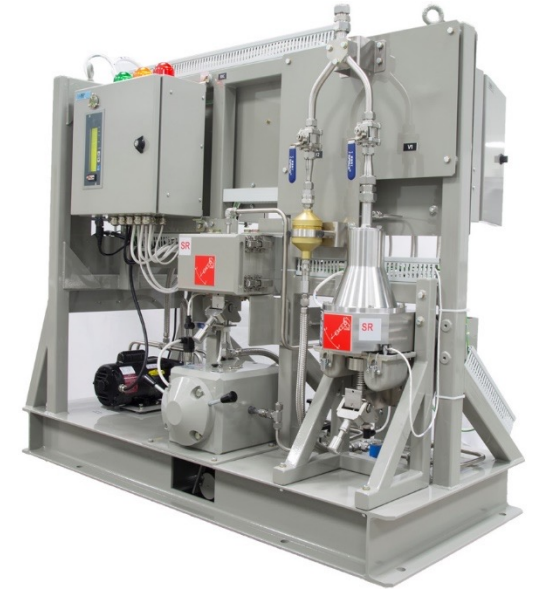
**PING 206S**

# RMS Troubleshooting

## What about this thing?
